Flexible Riser Cost Saving

The New Economic Reality

Cost Saving – The New Economic Reality

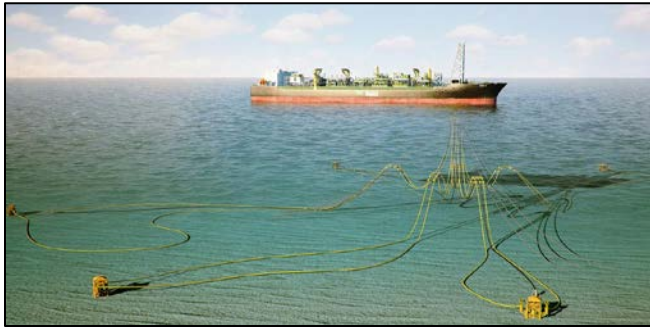
- 2015 : ROV inspection reveals catastrophic sheath failure below BSR
- Signs of gas leakage into open water
- Failure of subsea vent ports, leading to gas buildup, no annulus test
- Catastrophic sheath failure below BSR

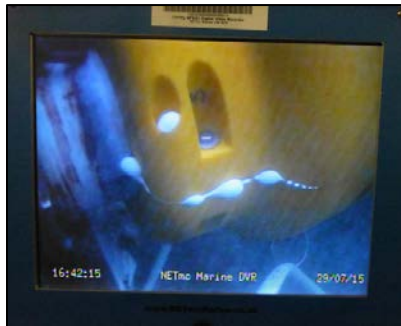
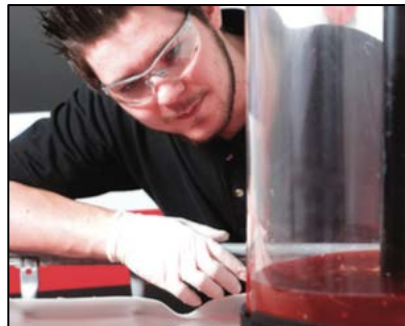
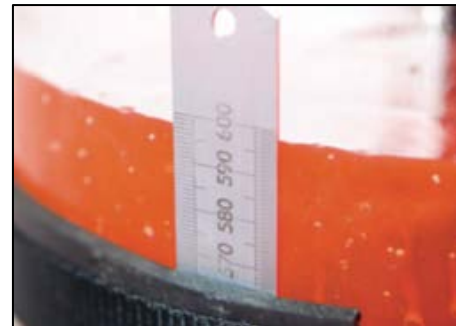
- Used within a confined area, such as Armadillo, J-tube, I-tube, or Caisson
- Prevents further corrosion by excavating oxygenated water from risk area
- Pumps as liquid and sets as rubber – suitable for dynamic risers
- Predetermined density minimizes quantities
- Environmentally friendly, CEFAS registered
- Compatible with PA11
